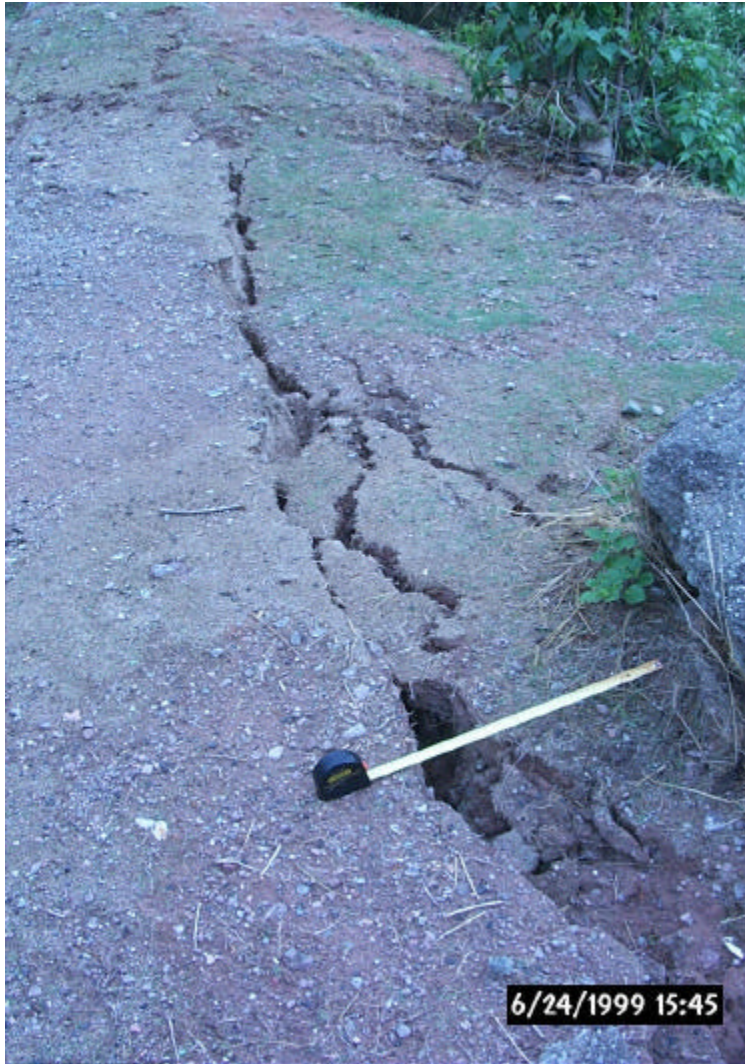
Figure 4.15 Slumping and cracking of soil near a steep slope adjacent to the highway at Puerto el Gato.

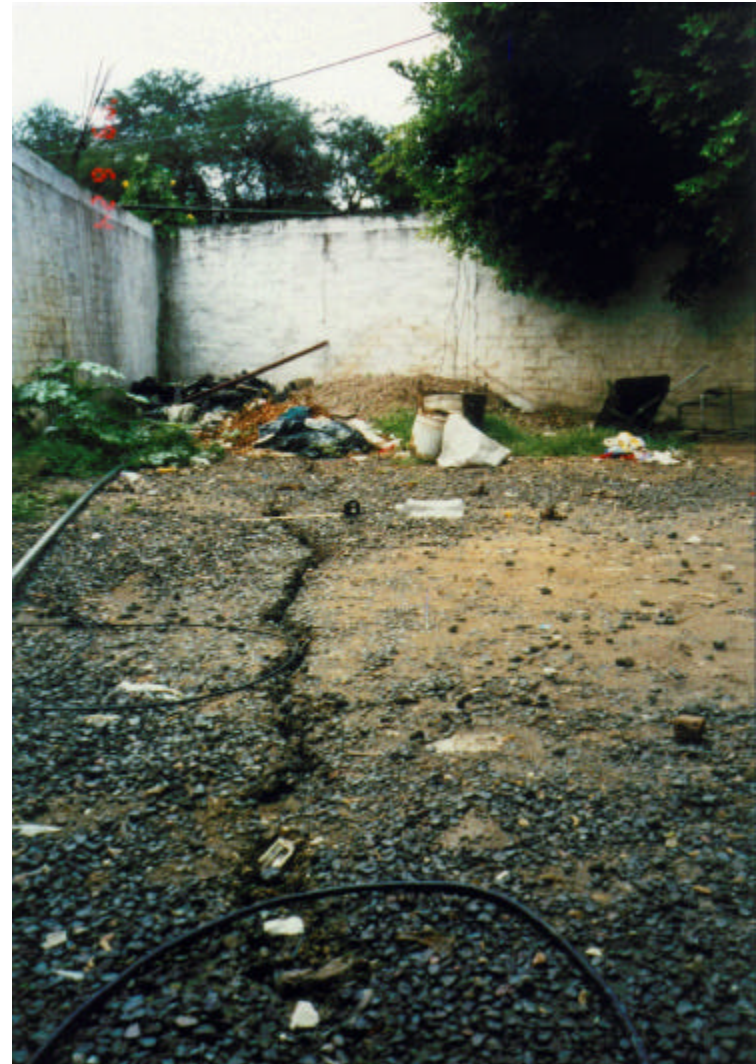
Figure 4.16 Lateral extension cracks in soil, Acatlán de Osorio.
