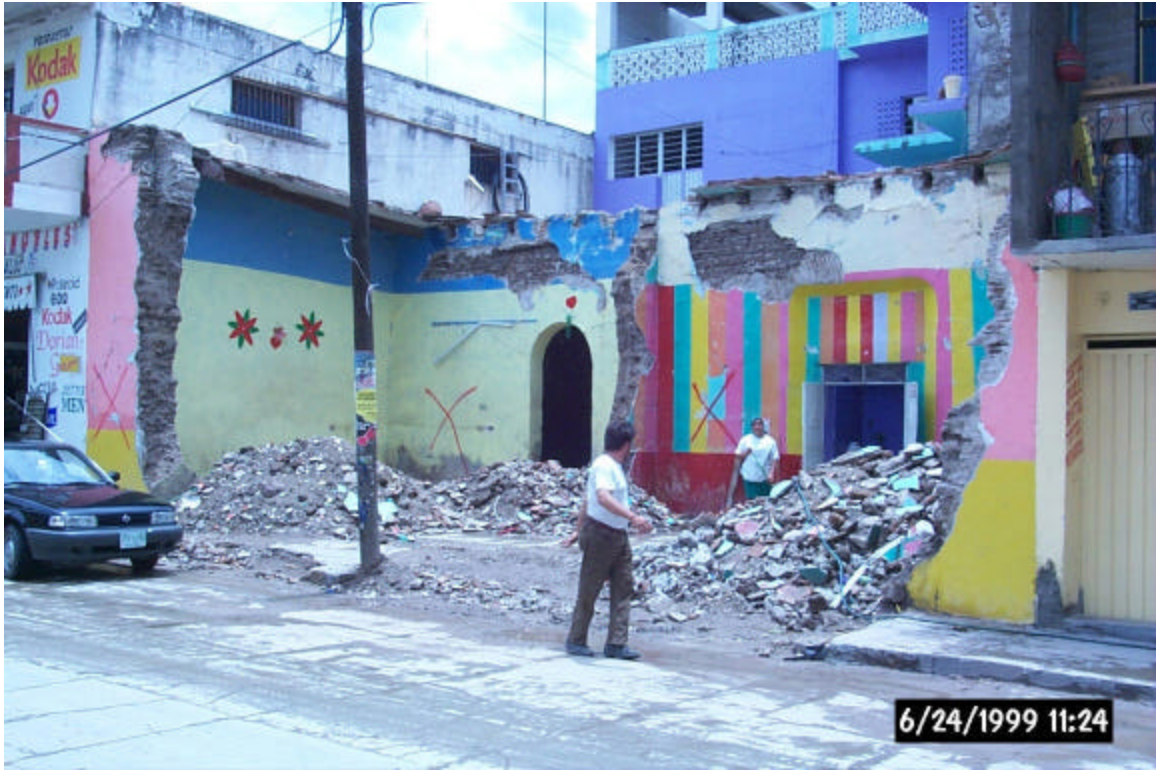
Figure 4.9 Demolished URM structure in Acatlán de Osorio.

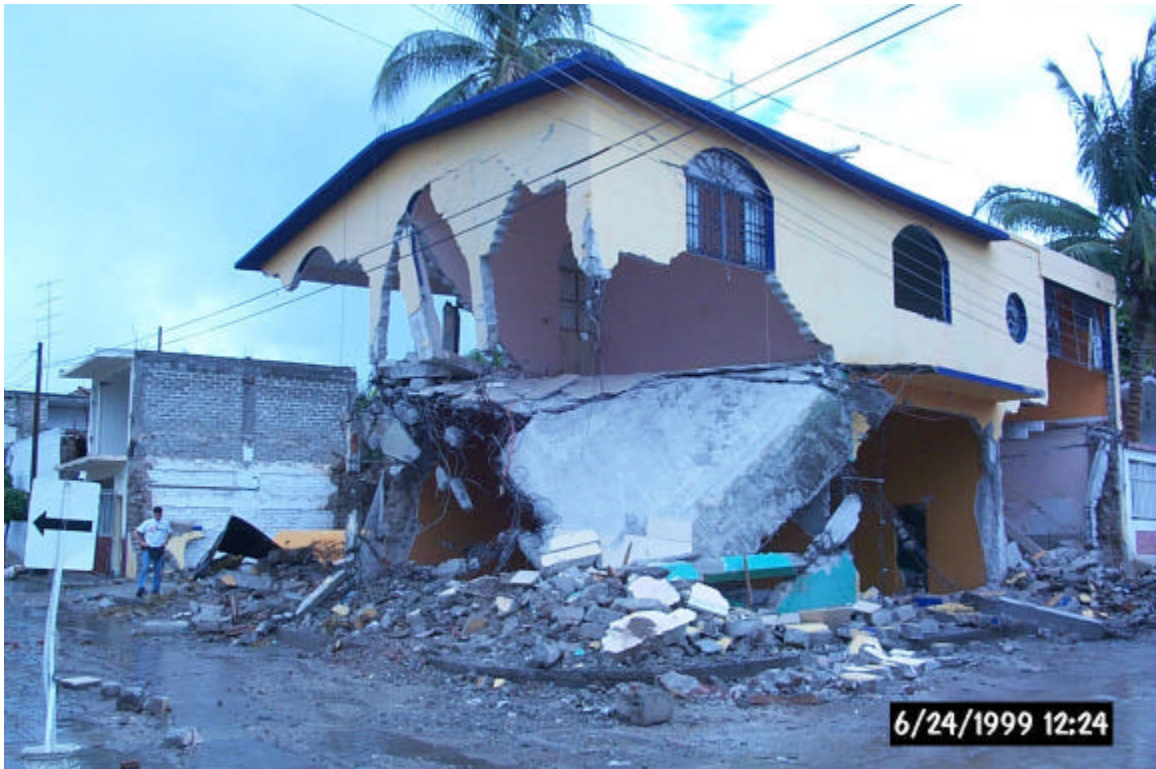
Figure 4.10 Damaged modern reinforced concrete structure in Acatlán de Osorio.
