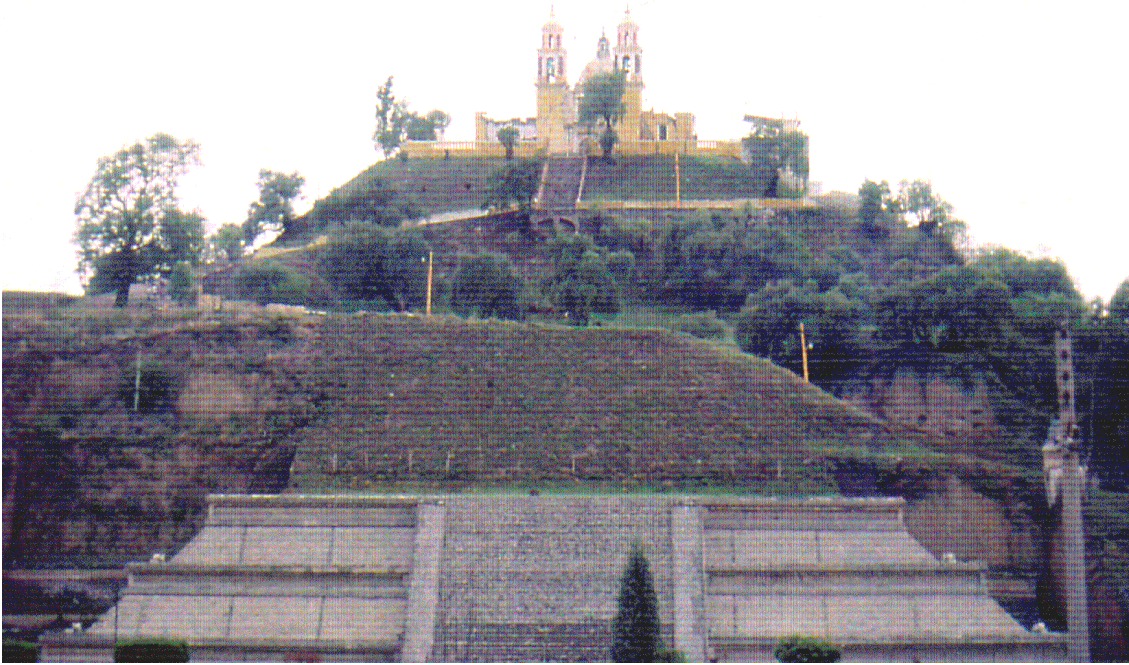
Figure 4.7 Church in Cholula founded on the top of an ancient stone pyramid.

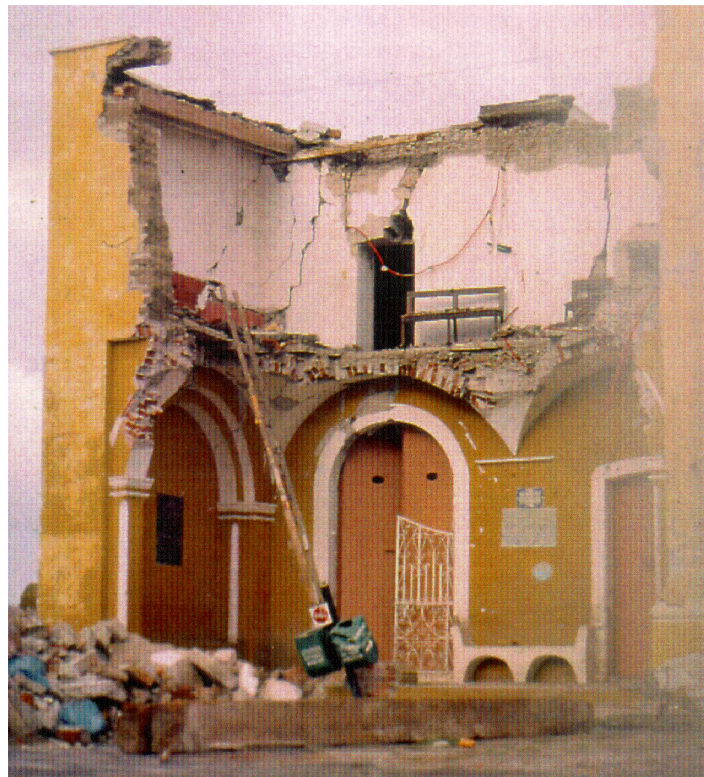
Figure 4.8 Damage to the Cholula church due in part, to topographic amplification of ground motions.
